## INTERPRETATION OF HIGH-RESOLUTION IMAGES FOR IDENTIFICATION OF DAMAGE TO RASANG AND LOST SHIP IRRIGATION CHANNEL KOTO TANGAH SUB-DISTRICT, PADANG CITY

\*Liza Septi Dhamara Asri<sup>1</sup>, Triyatno<sup>2</sup>

<sup>1</sup>D3 Remote Sensing Technology Study Program Student, Universitas Negeri Padang, <sup>2</sup>Lecturer Study Program D3 Remote Sensing Technology, Universitas Negeri Padang  
Email : lizaseptidhamara@gmail.com

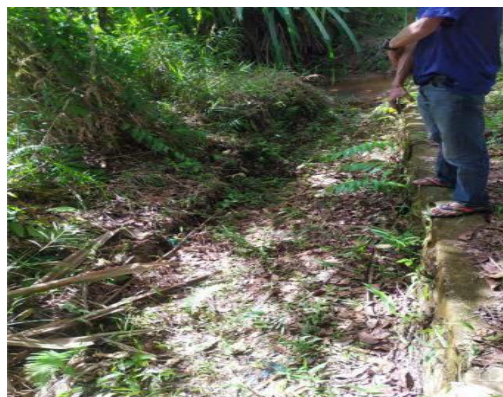
Figure 3. Damaged Kapalo Hilalang canal.

The Kapalo Hilalang irrigation network suffered heavy category damage from the weir building to the building for 1 Kapalo Hilalang which resulted in the breaking of irrigation channels along  $\pm$  1km. The rupture of the Kapalo Hilalang irrigation canal was caused by the 2009 earthquake which caused a cliff slide in the canal weir. In order to restore the damaged irrigation canals, the Kapalo Hilalang canal had to be rebuilt from scratch. As shown by figure 7 and the map below

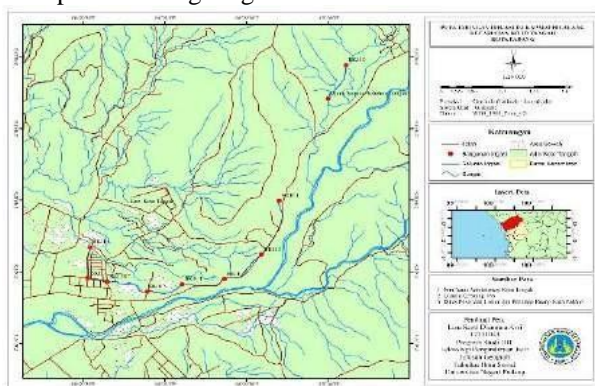
Figure 4. The shape of the damaged Kapalo Hilalang irrigation canal

The following is a map of the Kapalo Hilalang irrigation canal which was cut off 1 KM.

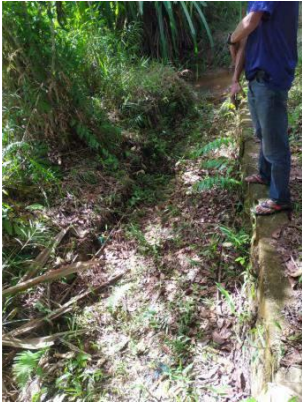
Build name	Documentation
BCH 0	 
End of Channel Before Landslide

From data in the table above it can be seen that BKH 0 was heavily damaged so the irrigation flow could not flow smoothly. BKH 1 has a length of 1,998 m, dimensions of 80 cm with a moderately damaged building condition. BKH 2 has a length of 767 m, and dimensions of 80 cm in moderately damaged condition. BKH 3 has a length of 567 m with dimensions of 80 cm in moderately damaged canal conditions. BKH 4 has a length of 51 m, and dimensions of 80 cm with moderate damage. BKH 5 has a length of 447 m, and canal dimensions of 100 cm with moderate damage. BKH 6 has a channel length of 520 m with dimensions of 100 and the condition of the building is moderately damaged. BKH 7 has a length of 224 m, the dimensions of the canal are 100 cm with good canal conditions and BKH 8 has a length of 405 m with dimensions of 100 cm, the condition of the building is good.

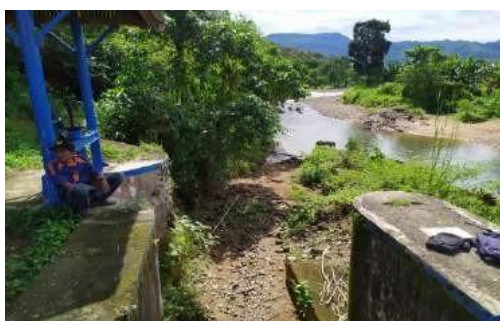
Figure 15. Kasang II Dam covered by sediment

The irrigation canal in Kasang II was only slightly damaged with thick sediment conditions and a slight shift in irrigation structures. Casting channels are classified as moderately damaged so they only need repair/rehabilitation of the channels. As shown in Figure 8 and the map below.
