UTILIZATION OF IMAGE SENTINEL-1 SAR FOR IDENTIFICATION OF FLOOD DISTRIBUTION AREA In PANGKALAN KOTO BARU SUMATERA DISTRICT

ABSTRACT: This research was conducted to determine the flood distribution area in Pangkalan Koto Baru District. Using the Normalized Difference Sigma Index (NDSI) method. By using this remote sensing method, it is possible to identify the flood distribution areas in Pangkalan Koto Baru District on March 15 2017.

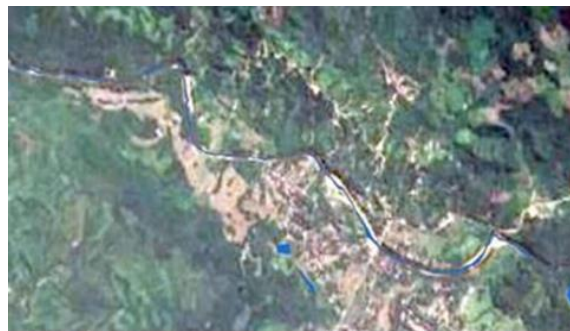
The results of the extraction of flood inundation in the image on February 20 2017 show that the extracted water body vector pattern only appears to follow the flow pattern of the river which does not overflow and is by the river network. The area for water bodies on February 20 in the research focus area is 26.18 Ha.

Fig. 6 Date Permanent Water Body Appearance
20 February 2017

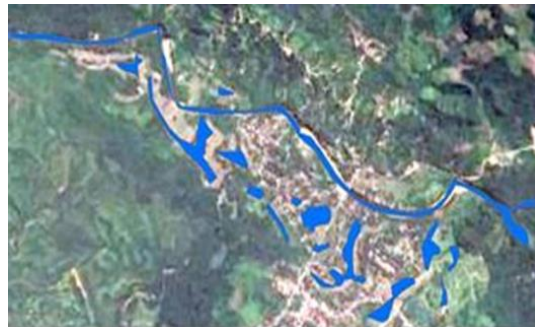
The results of the extraction of flood inundation in the image on March 15 2017 show that the vector pattern of water bodies extracted from the river flow is very visible, overflow or inundation which is identified as a flood inundation. The area for water bodies on March 15 in the research focus area is 76.22 Ha.

Fig. 7 The appearance of a Body of Water During a Flood March 15, 2017

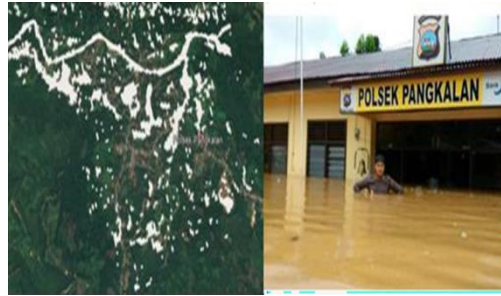
Fig. 8 The Appearance of the Base Police in a Flood

The validation related to the flood disaster in Pangkalan Koto Baru District obtained is as follows:

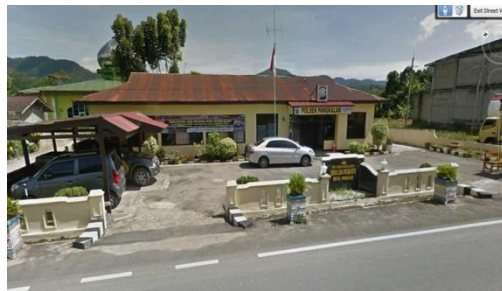
Fig. 9 The appearance of the Base Police in 2020
